**CWA COMPLIANCE EVALUATION INSPECTION REPORT
U.S. ENVIRONMENTAL PROTECTION AGENCY, REGION 5**

Compliance Evaluation Sampling Inspection

Sandway Farm, LLC

April 18, 2013

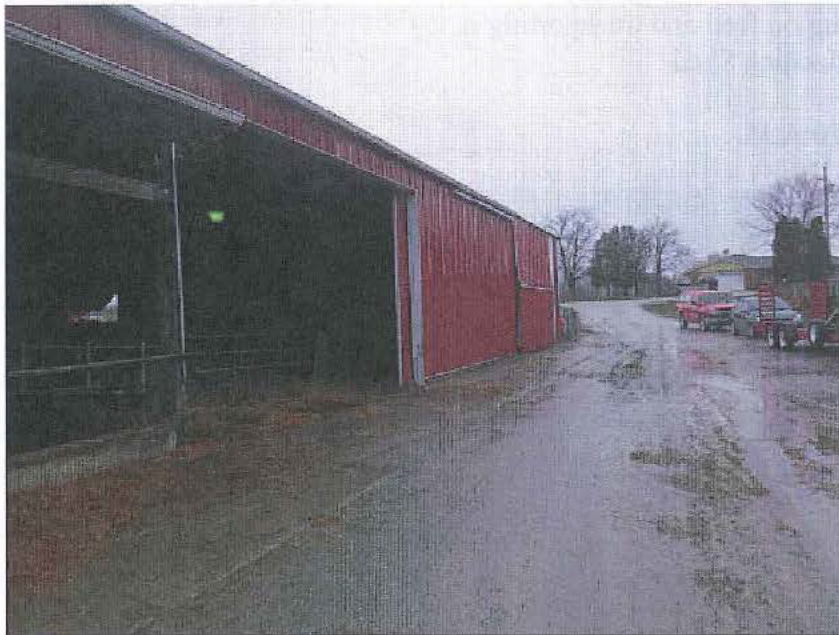
IMGP0004: Machine Shed on west side of facility also houses a dozen close-up dry cows.

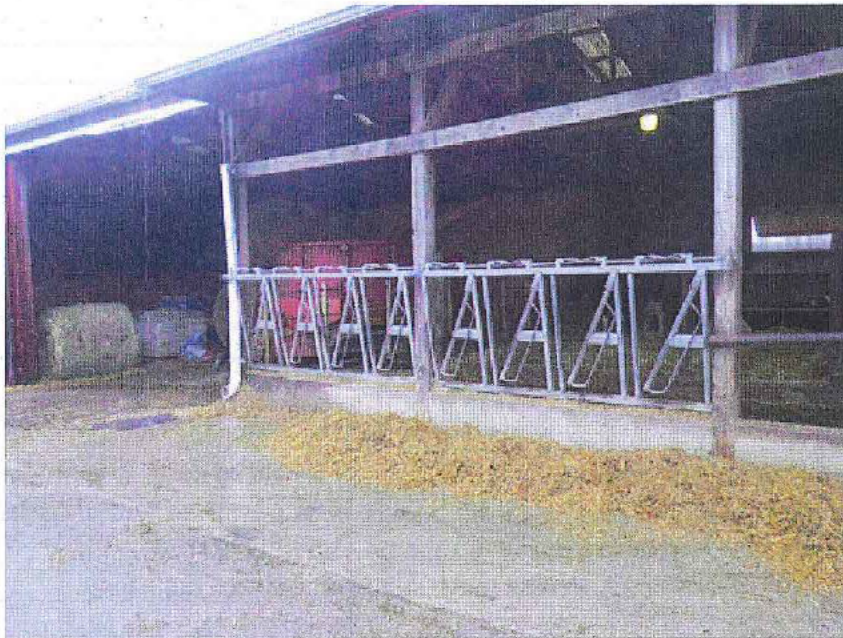
IMGP0006: A roof overhang and eave gutters on Machine Shed help keep the precipitation from landing on feed and transporting it.

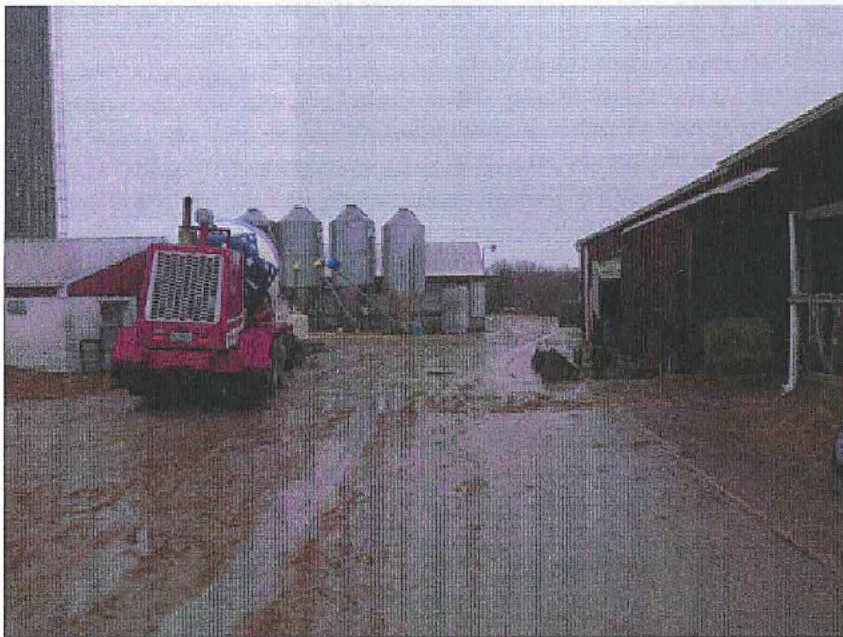
IMGP0007: Small amount of track in/track out in front of Machine Shed.

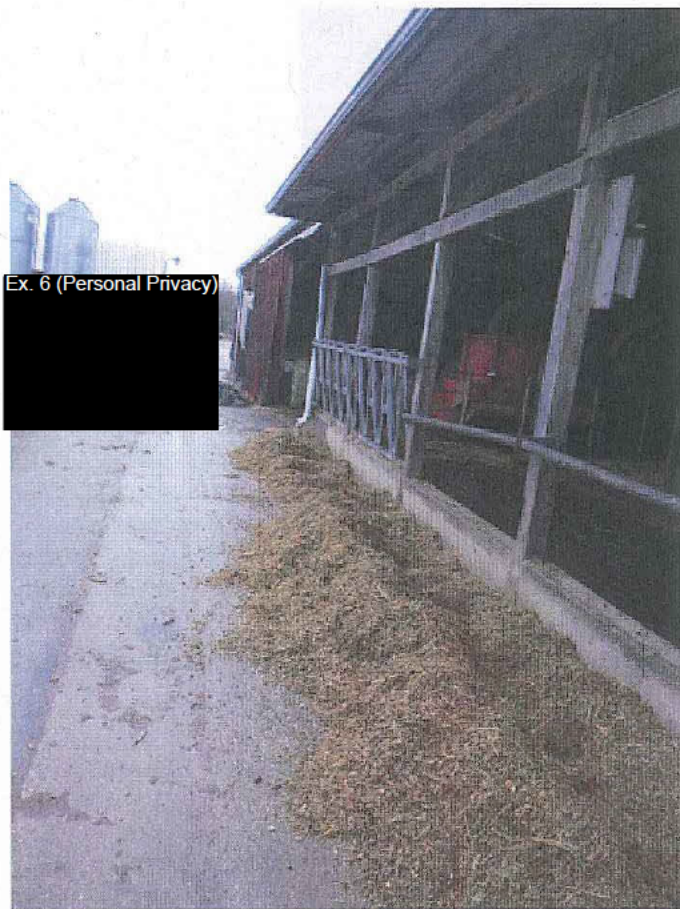
IMGP0008: Feed for close-up dry cows is open to the elements.

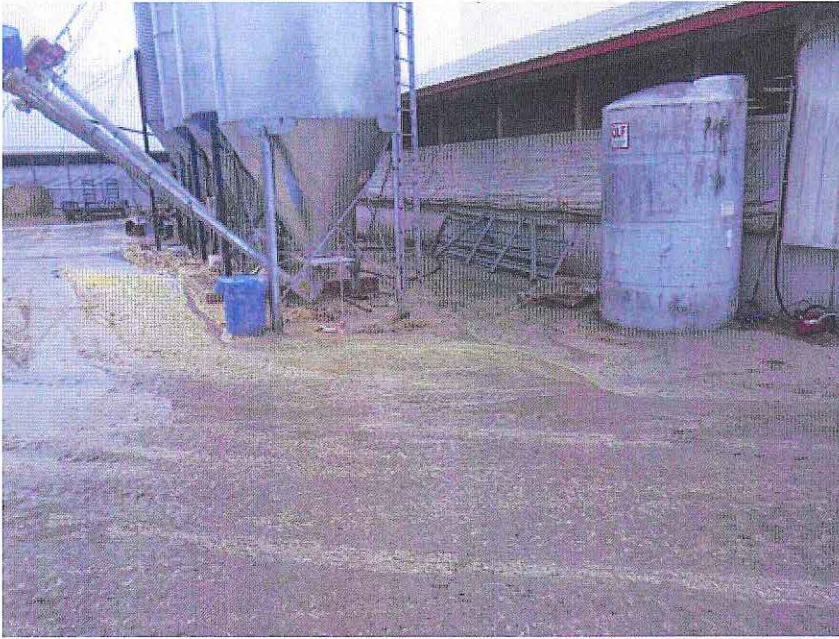
IMGP0013: Feed below the bulk bins can be transported with storm water to the south.

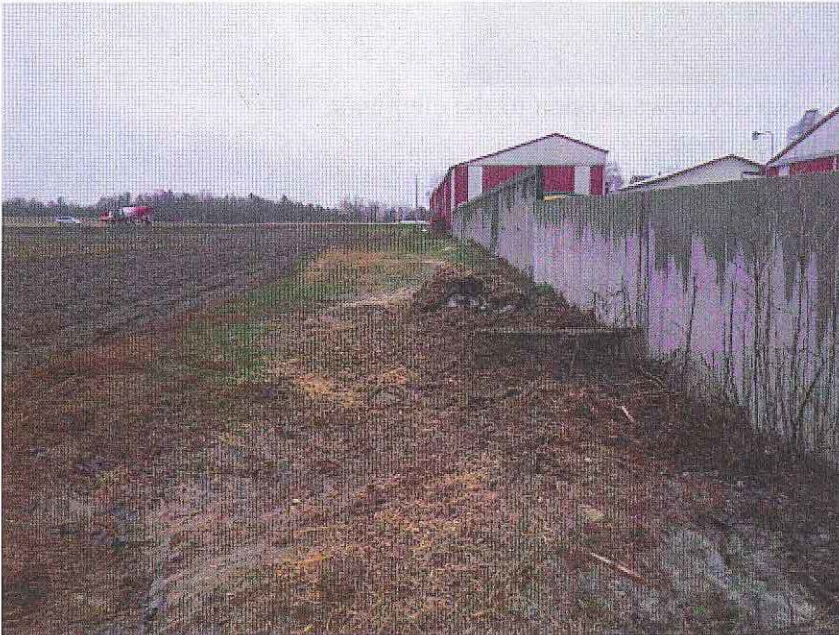
IMGP0017: Silage spilled on the ground west of the Silage Bunker can be transported to the West Ditch. There is snow piled under the silage.

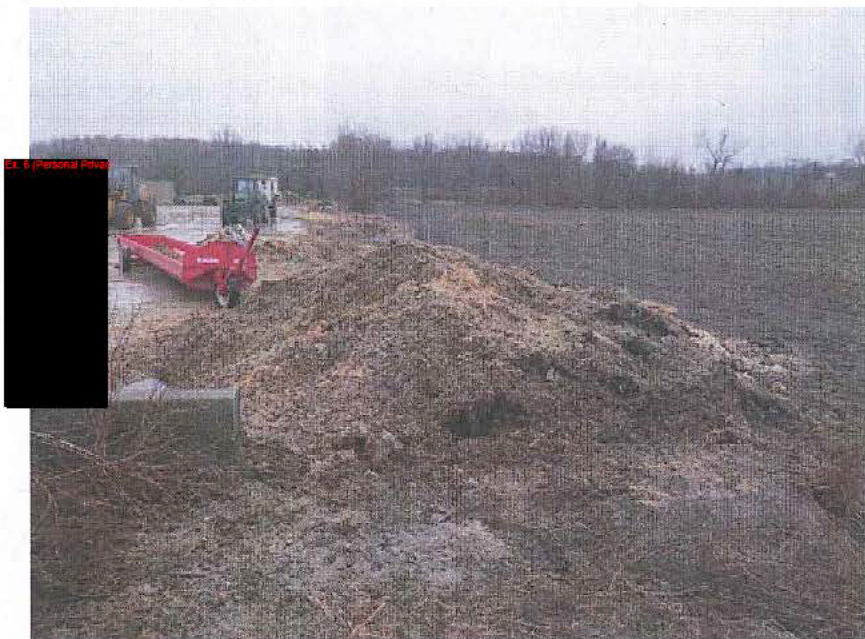
IMGP0018: Snow and silage from silage pad are pushed off the silage pad into the West Ditch.

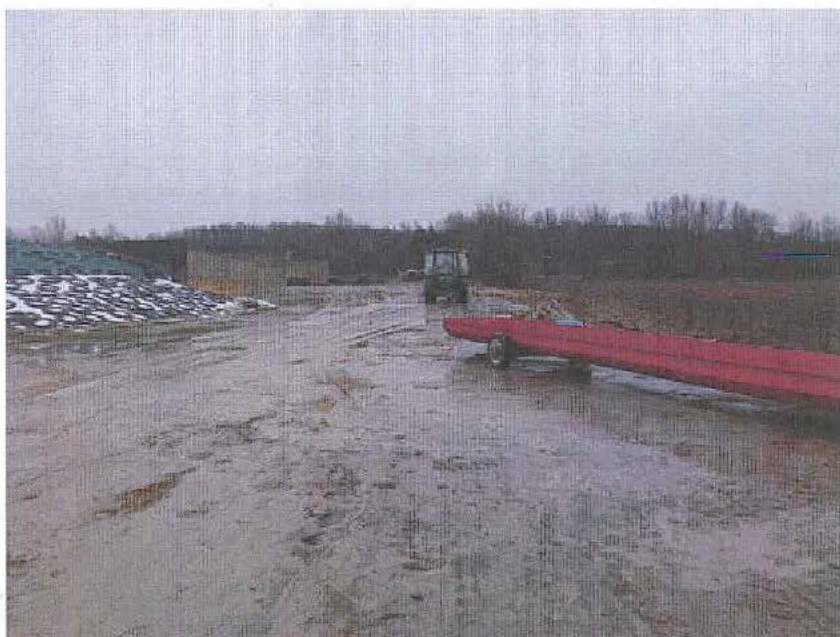
IMGP0022: Silage pad has no berm on the west side to prevent leachate from flowing into the West Ditch.

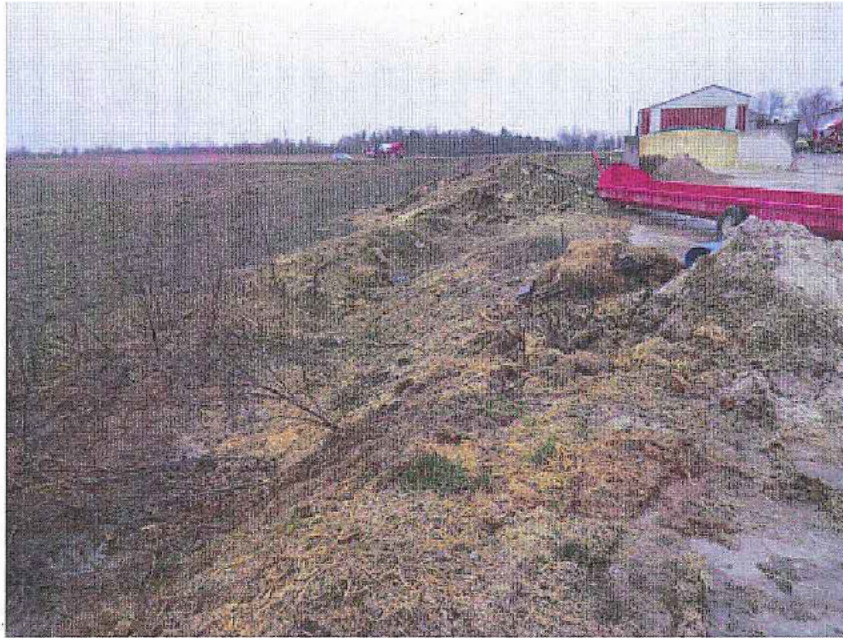
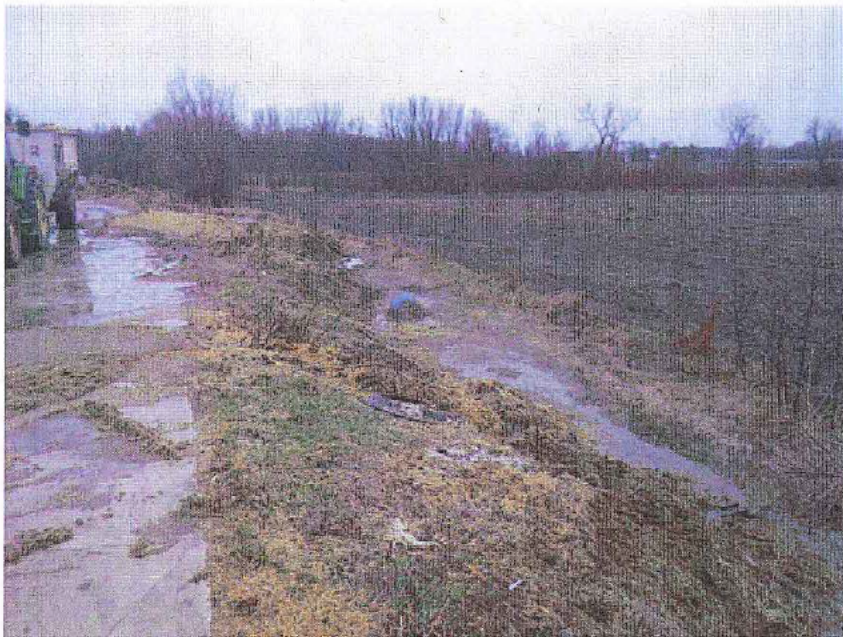
IMGP0024: West Ditch has flow in it under the silage that has been pushed off the silage pad.

IMGP0025: West Ditch has flow in it under the silage that has been pushed off the silage pad.

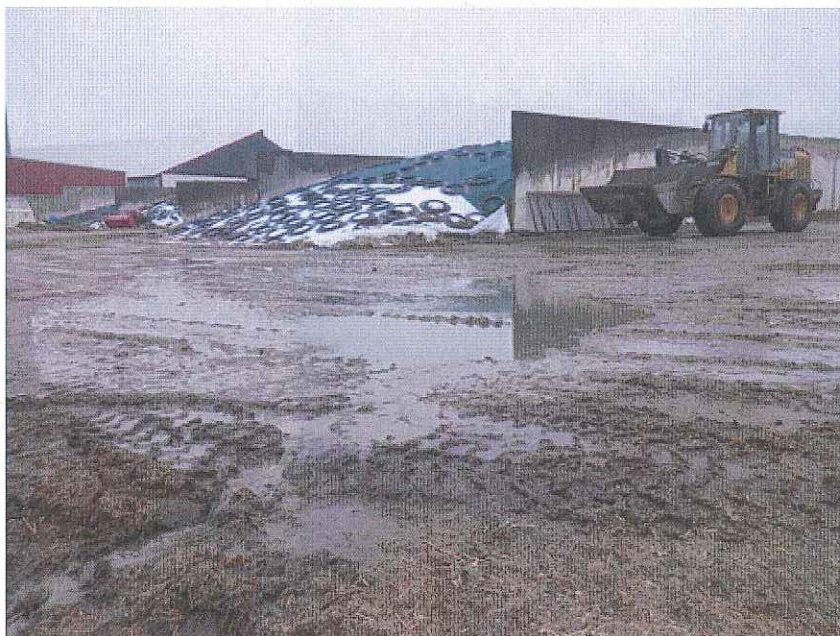
IMGP0027: Flow of surface water from the silage pad to the West Ditch. Note that there is water in the channel leading off from the silage pad.

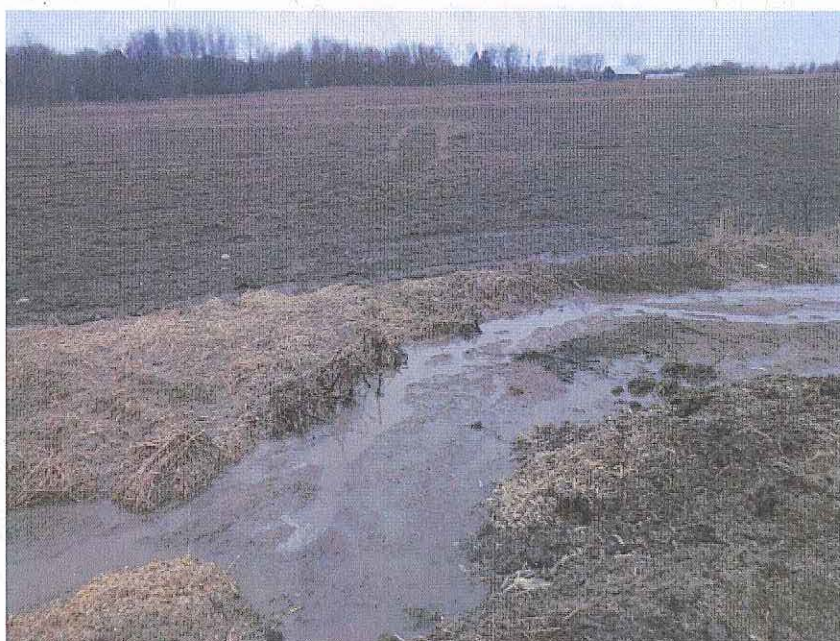
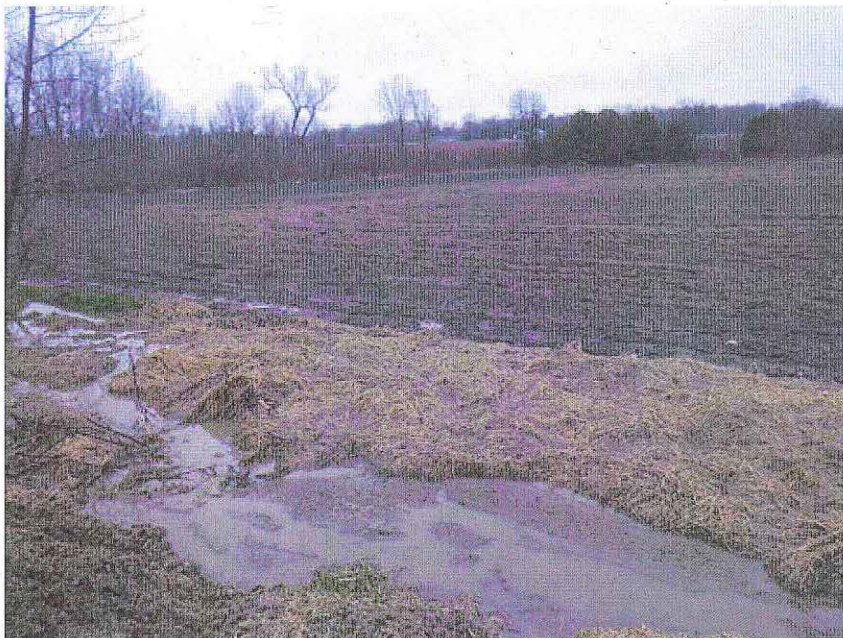
IMGP0031: Flow of water in the West Ditch and through the silage that is pushed off silage pad.

IMGP0032: Flow of water in the West Ditch and through the silage that is pushed off silage pad.

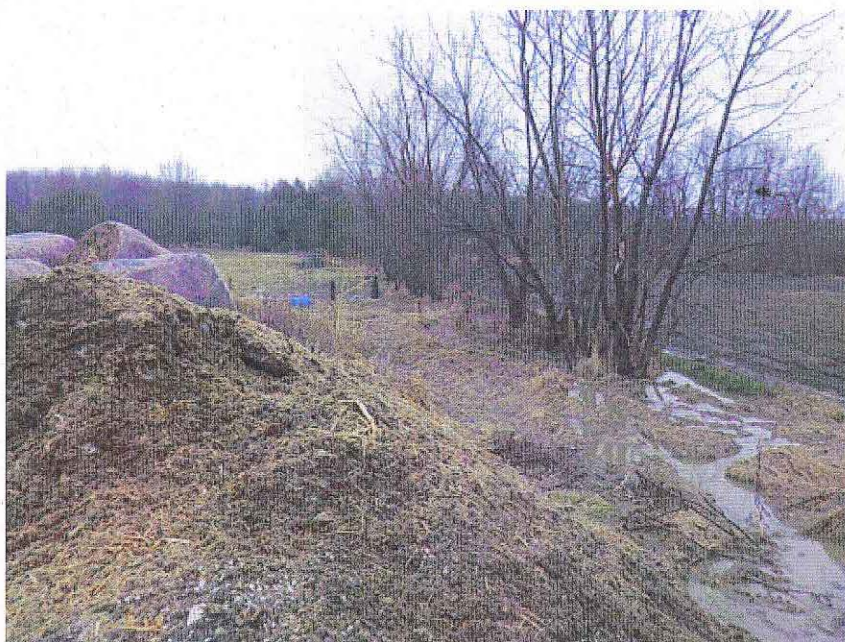
IMGP0033: Another pile of snow and silage from the silage pad is piled on the southwest corner of the silage pad.

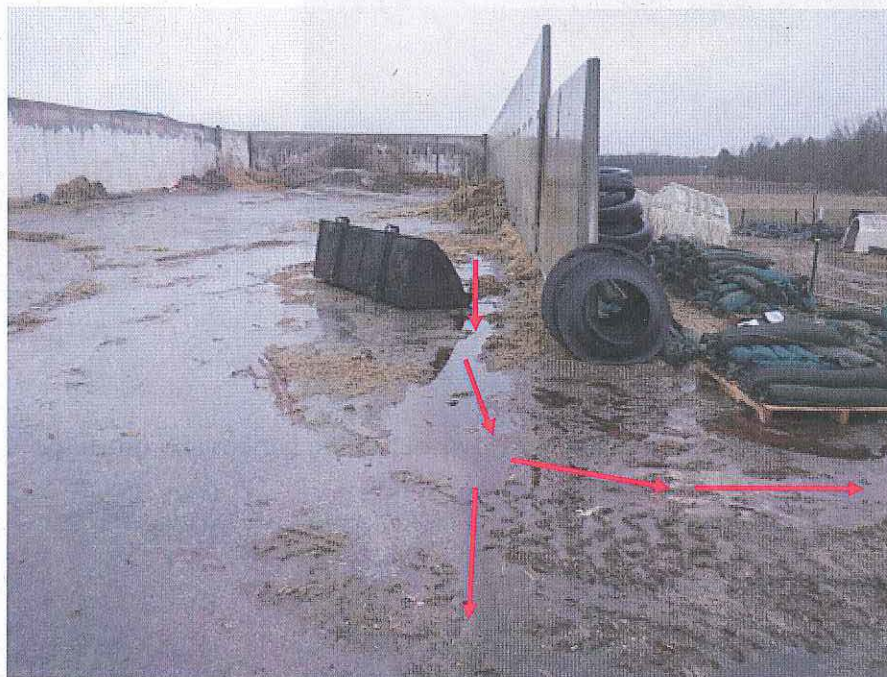
The southernmost feed storage bunker was being used to store manure solids. A flow of process wastewater from the manure stack flowed out of the bunker and some turned to the south where it went down the driveway to a pasture south of the feed storage bunkers, Pasture #1. Process wastewater from the manure stack also flowed directly to the west to the West Ditch.

IMGP0040: Manure is stacked in the southernmost Silage Bunker. Process wastewater pathway from the manure is identified by red arrows.

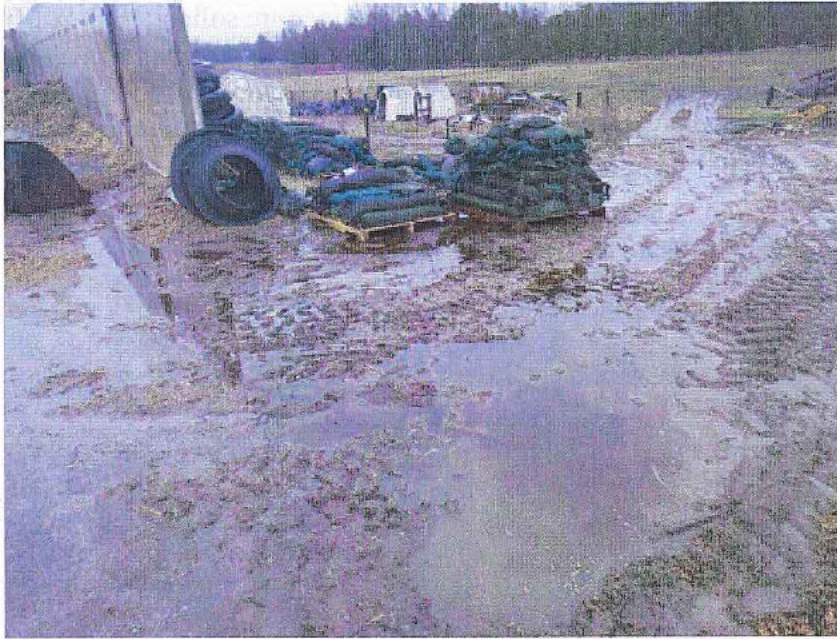
IMGP0041: Process wastewater from the manure flows out of the bunker and down the driveway to Pasture #1 and to the West Ditch.

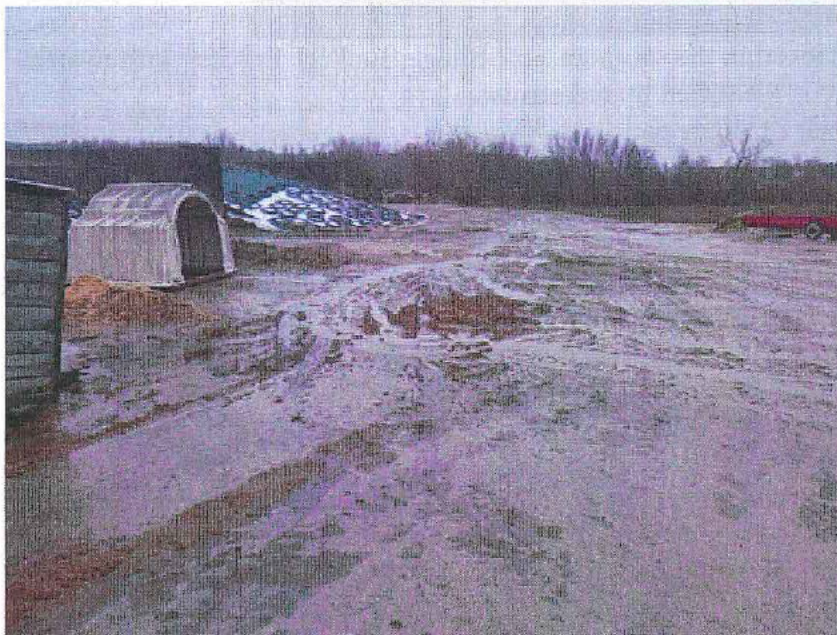
EPA noticed that the silage pad was tilted to the west so that flow of precipitation would flow off the pad to the west. There was nothing in place to prevent the raw materials and leachate from flowing with the precipitation to the west and to the West Ditch or to the south and to Pasture #1.

IMGP0042: Silage pad is tilted to the west. There is no curbing to prevent process wastewater from reaching the West Ditch.

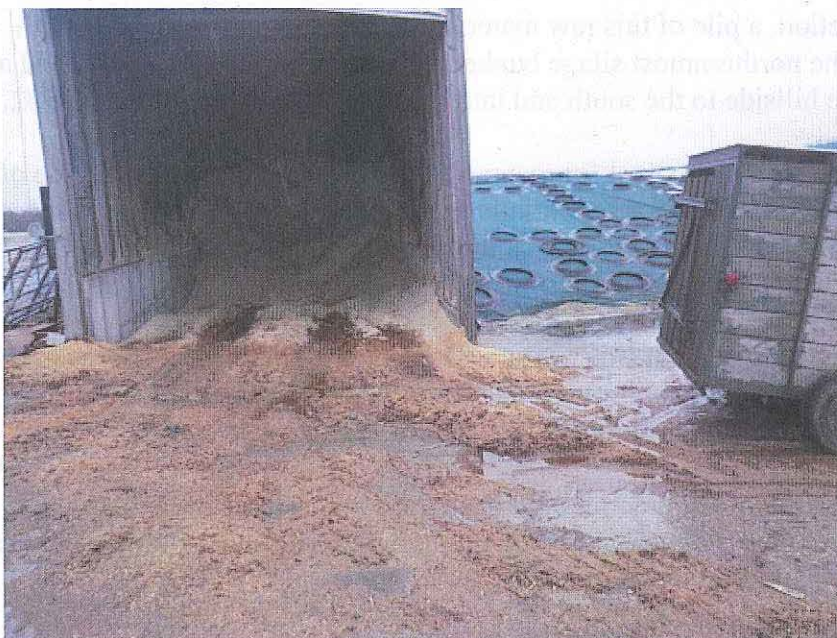
IMGP0043: Sawdust stored in bunker has a significant amount of track in/track out.

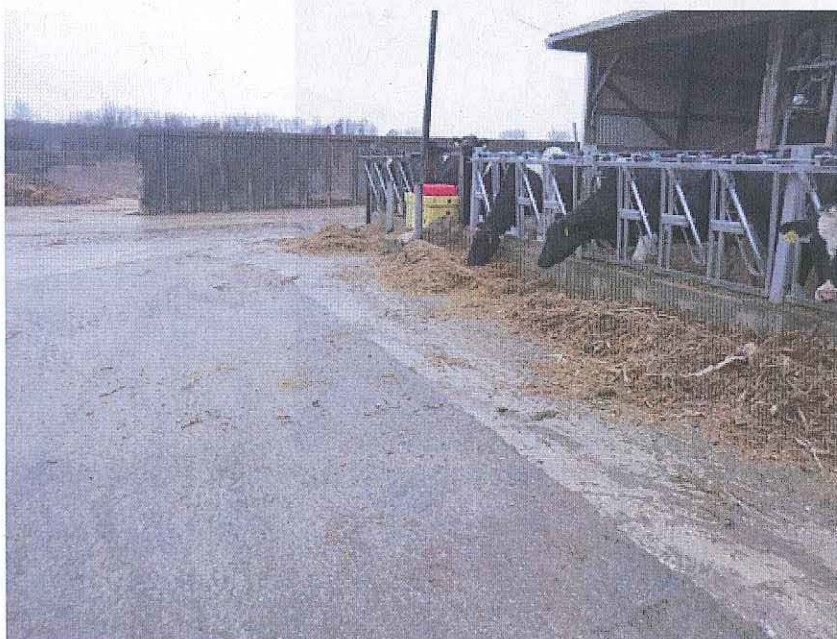
IMGP0045: Feed for dry cows can be transported by precipitation to the West Ditch.

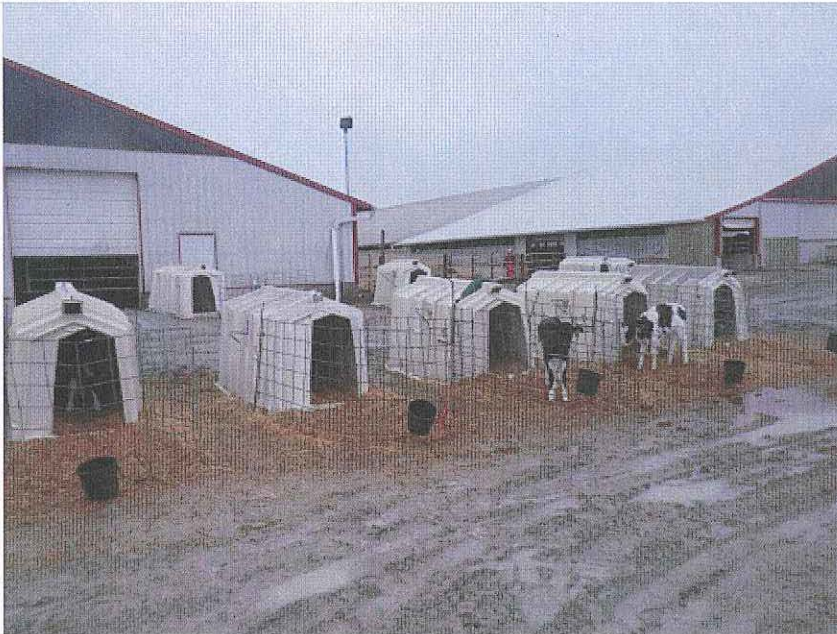
IMGP0056: Calf hutches on south side of Barn #2. No containment for runoff from the calf hutches and runoff is able to flow to Pasture #2.

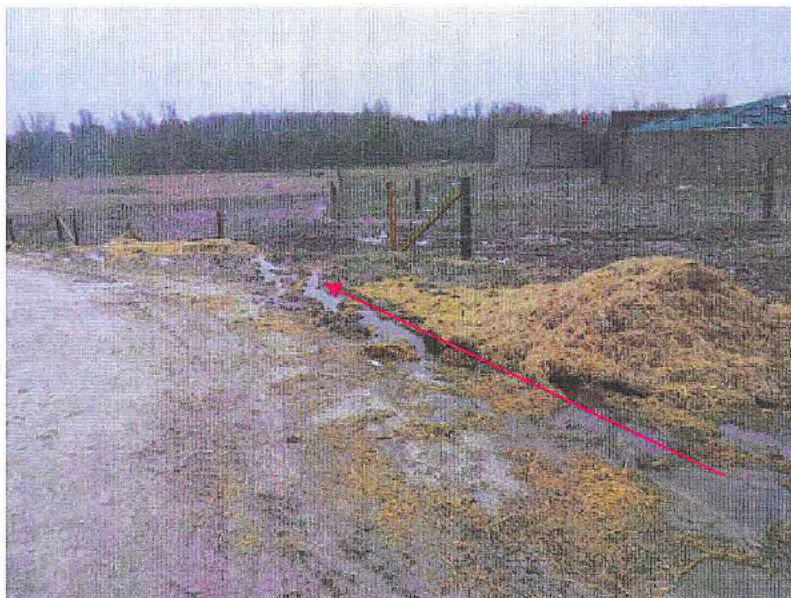
EPA observed channelization of the precipitation from the south side of Barn #2 to the north side of Pasture #2. The precipitation flowed through piles of used bedding from the calf hutches before flowing to Pasture #2.

IMGP0057: Channelization of flow from the south side of the Dry Cow Barn and the south side of Barn #2. Flow goes through a pile of used bedding from the calf hutches. Red row denotes location and direction of flow.

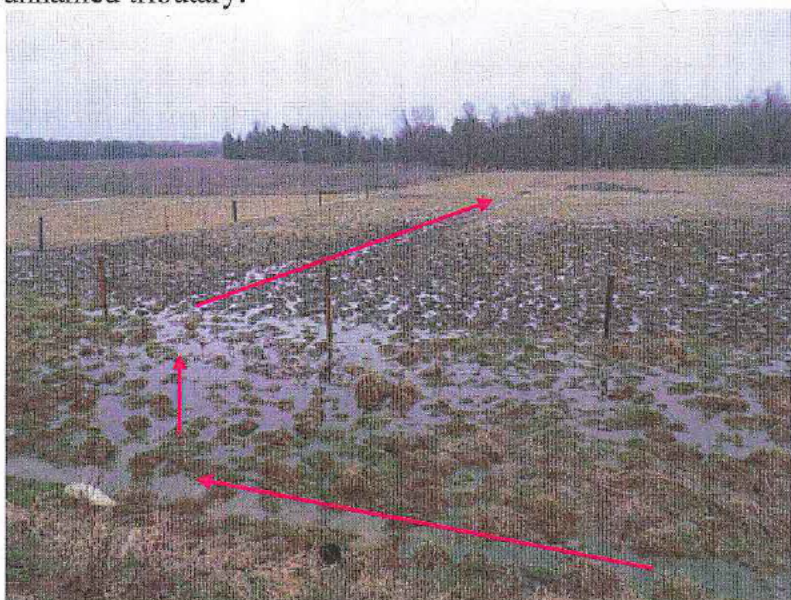
IMGP0062: Flow pathway through Pasture #2 flows to the south. Red arrows denote general flow pathway location and direction.

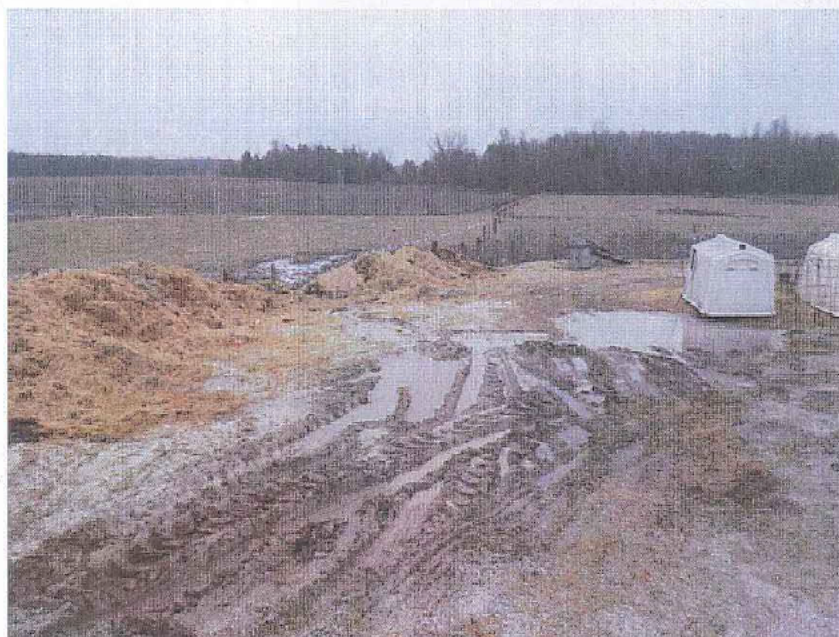
IMGP0064: Bedding from calf hutches on top of snow pile pushed to southeast corner of calf hutches area. Fence line delineates Pasture #3 on left from Pasture #2 on right.

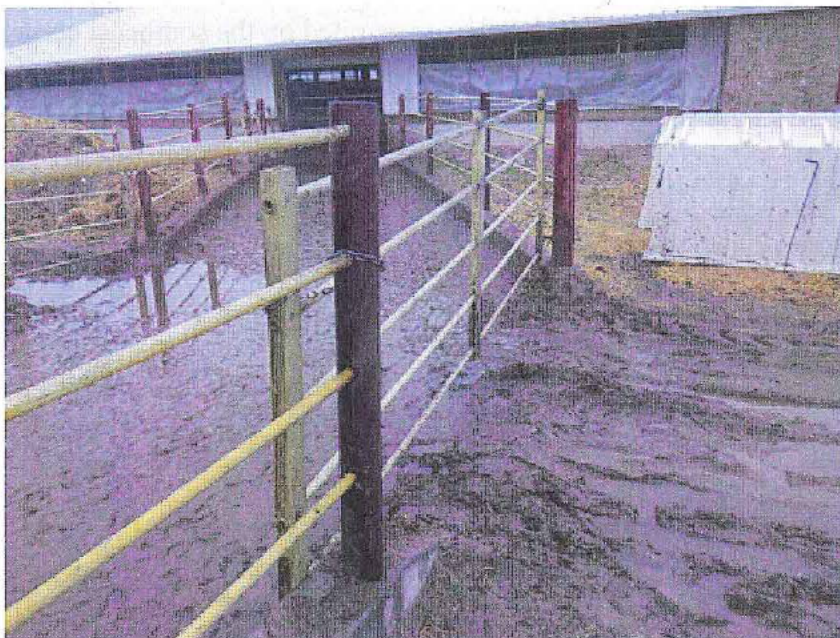
EPA also noted that the cattle walkway from Barn #2 to the Main Barn did not have complete containment for the manure and process wastewater. Manure and process wastewater from the walkway could flow with precipitation to the south.

IMGP0065: Cattle walkway from Barn #2 does not have complete containment for manure and process wastewater.

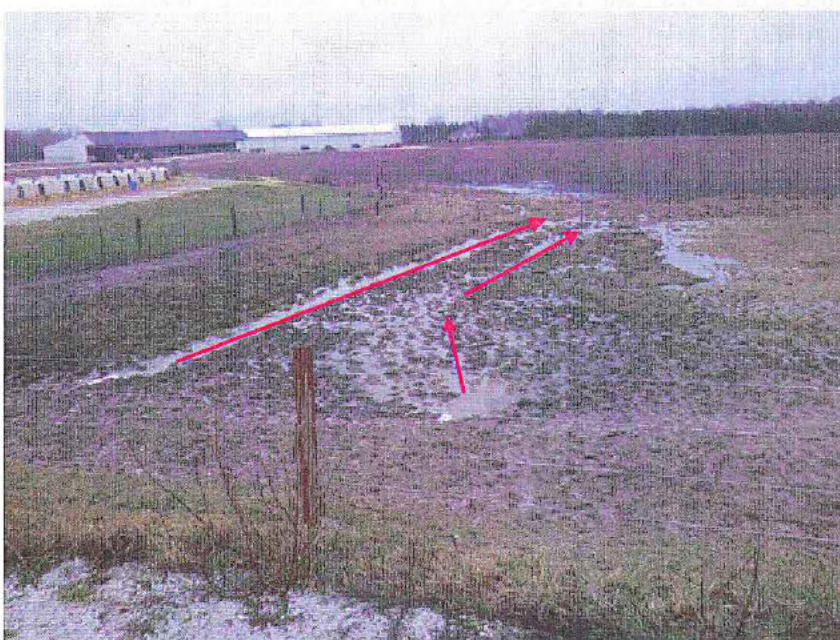
Since the production area is elevated, EPA could see the layout of the pastures below. In the northwest corner of Pasture #3, EPA observed two white pipes that appeared to be discharging flow. The flow of liquid went to the east then turned to go to the south.

IMGP0069: White pipes discharge storm water to Pasture #3 which channels and flows to the east side of the Pasture #3. Red arrows denote location and direction of flow from the white pipes.

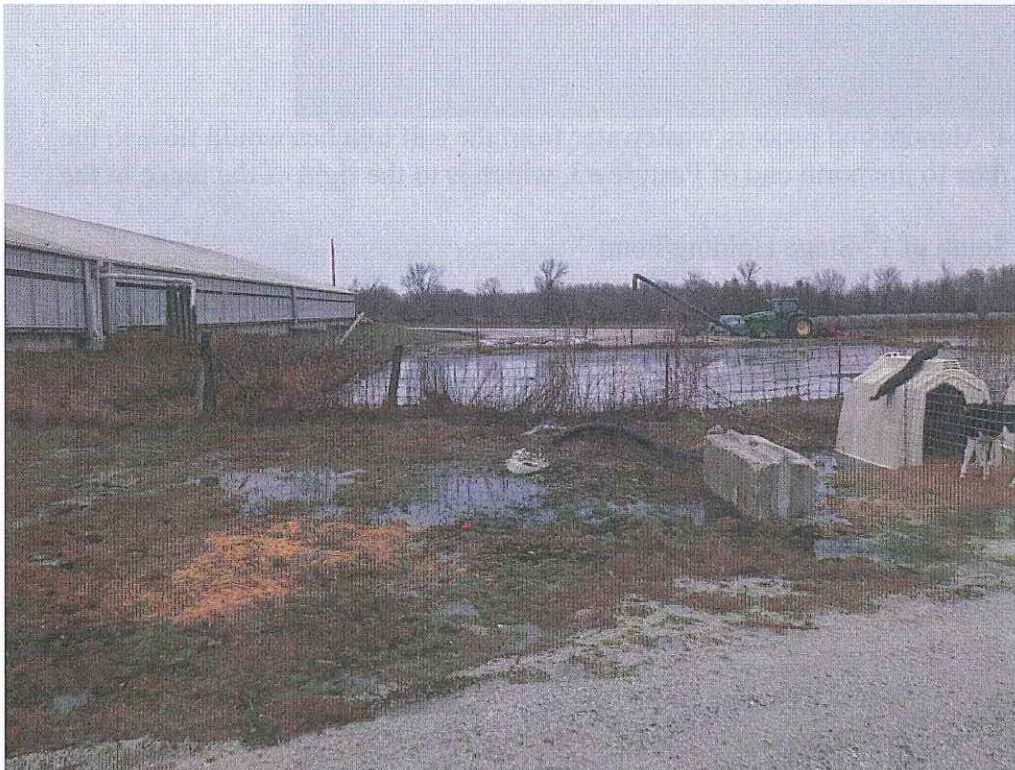
The holding pond on the west, the 1st Stage Holding Pond, was a concrete lined square manure pond. It was very full and had less than six inches of freeboard. EPA observed additional calf hutches on the south side of the pond. There was no containment for the manure and process wastewater from the calf hutches. Manure and process wastewater from the calf hutches would flow to the south and to the north end of Pasture #3.

IMGP0072: 1st Stage Manure Holding Pond is just to the east of the Main Barn. The holding pond is full. Manure channel from Main Barn is under the white pipe on the east side of the barn.

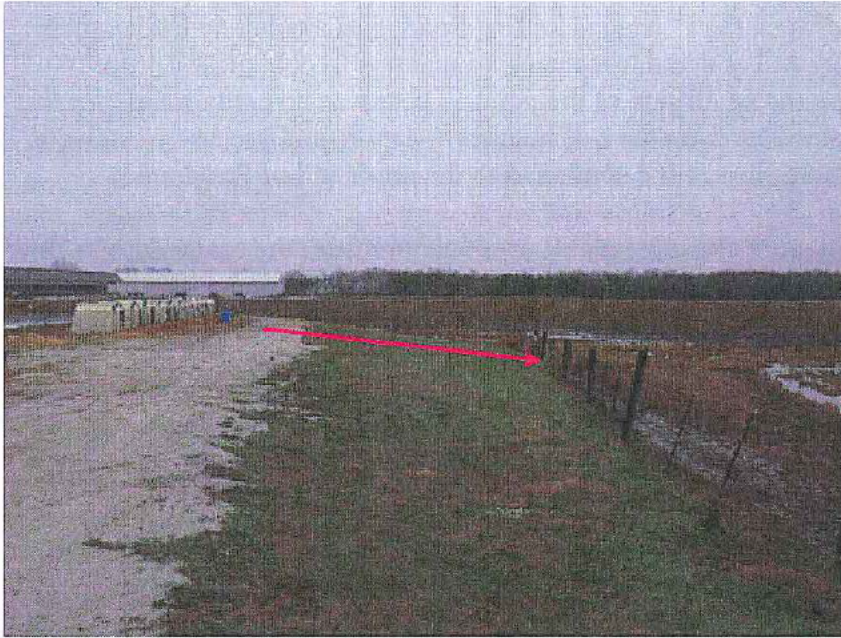
IMGP0074: Manure and process wastewater from the calf hutches would flow to the south and then to the north end of Pasture #3, which is to the right of the fence in the photo.

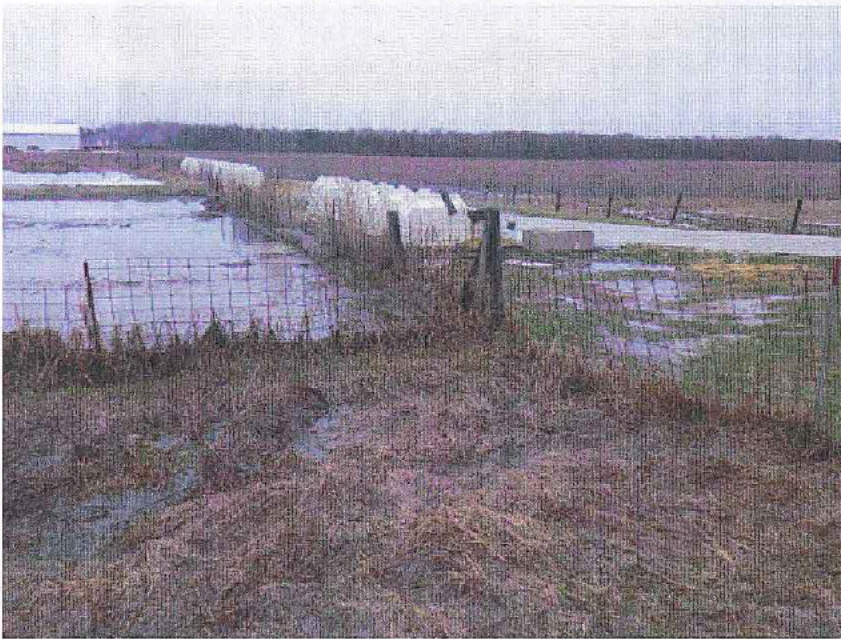
IMGP0075: Southeast corner of 1st Stage Holding Pond. Holding pond is full and appears to have overtopped the wall.

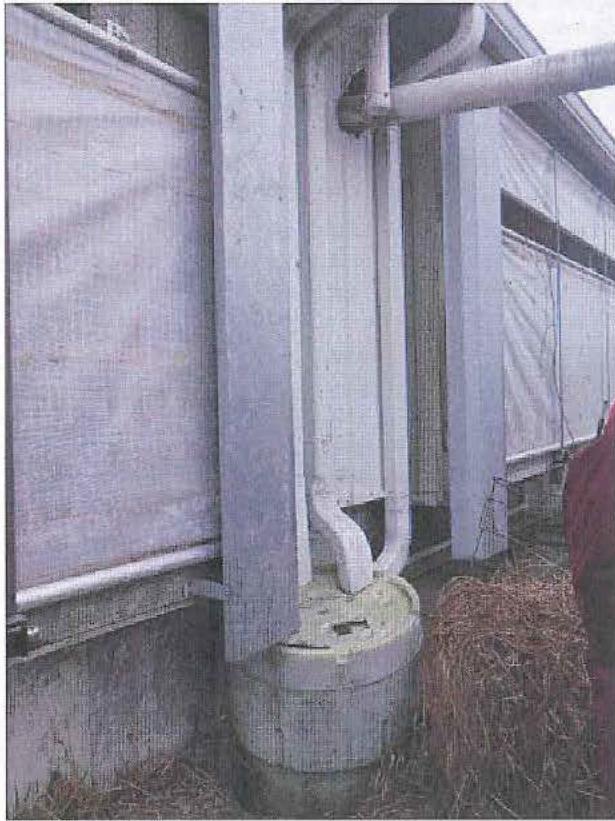
EPA observed that the eave gutters on the Main Barn were tied into downspouts. [REDACTED] stated that the storm water discharged through one of the white pipes that EPA previously saw in the north side of Pasture #3 (photo IMGP0069).

IMGP0076: Eave gutters are piped and discharge through a white pipe in the hillside on northwest corner of Pasture #3 (IMGP0069).

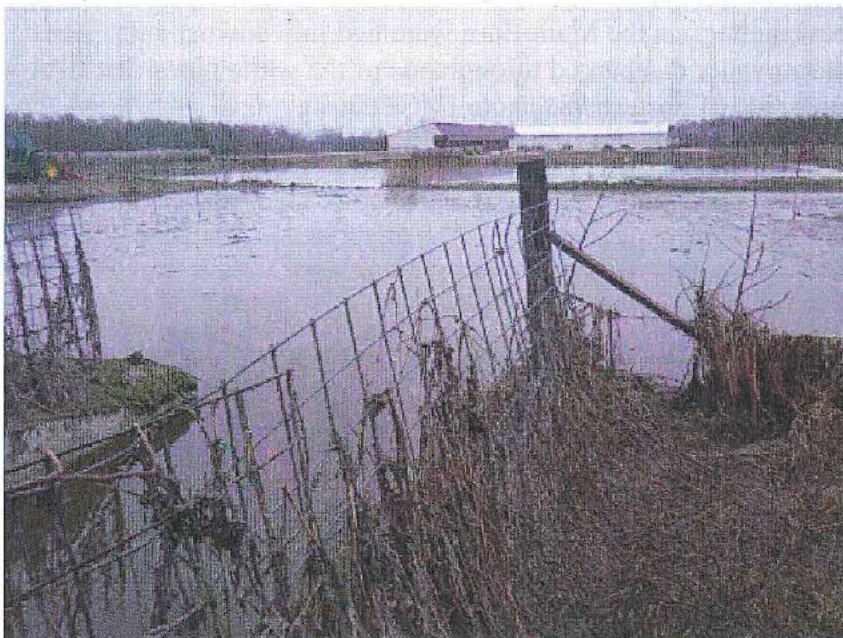
IMGP0077: 1st Stage Manure Holding Pond is full and backing up into the channel for the Main Barn. Manure solids on vegetation between the pond and the barn appear to indicate that the pond had overflowed.

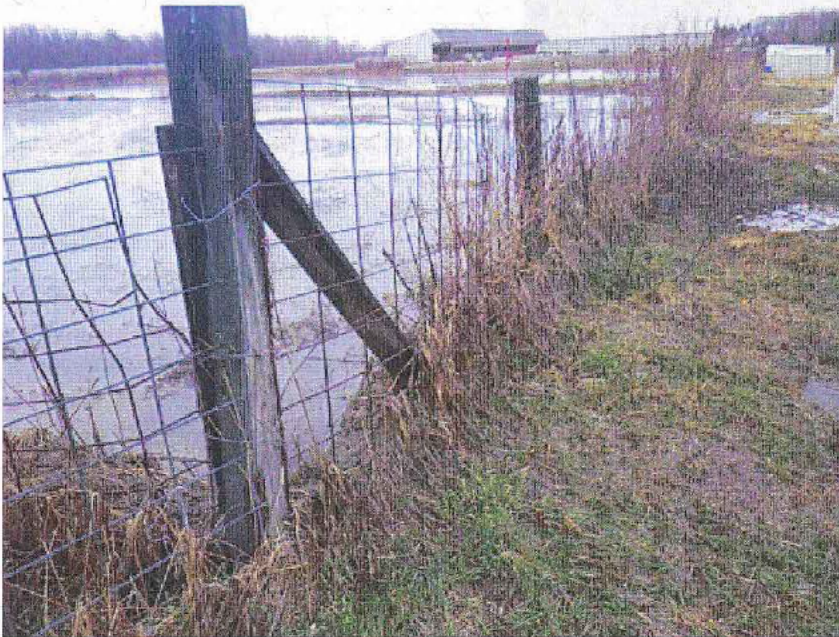
IMGP0080: It appears that the 1st Stage Manure Holding Pond overflowed onto the ground. Note the berm between the two ponds is barely above the manure level.

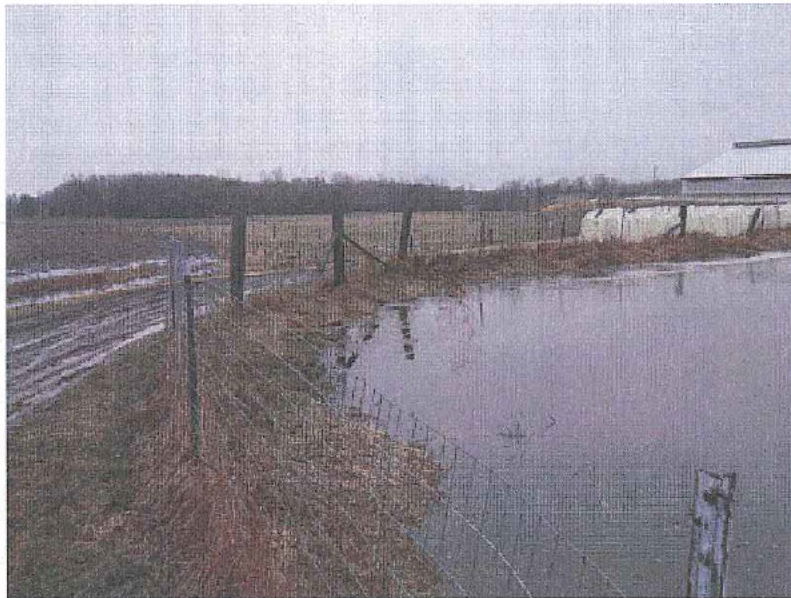
IMGP0085: 2nd Stage Manure Holding Pond is full. Five tanker trucks were lined up to remove manure from this pond when EPA arrived at the facility.

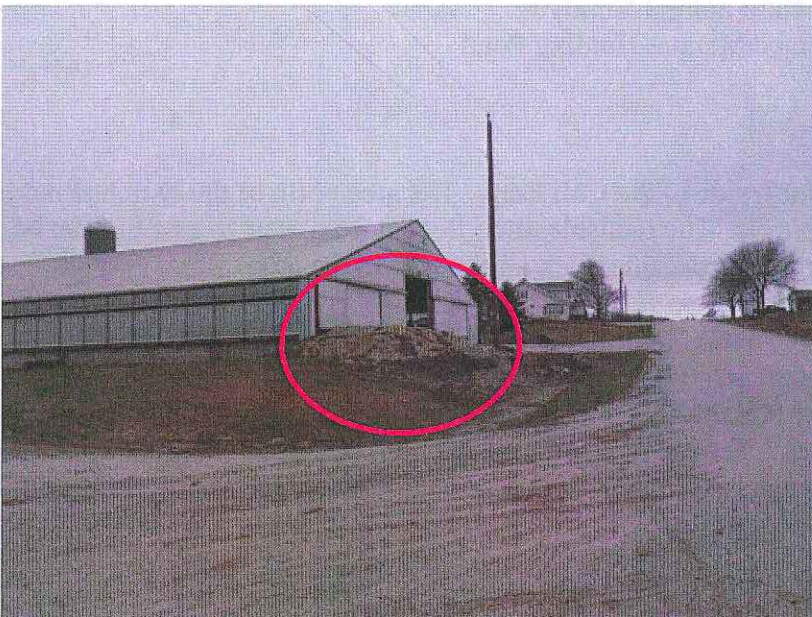
At the northeast corner of the Main Barn, EPA observed piles of manure and used bedding at both the northeast and northwest corners of the Main Barn that had been manually scraped out of the barn and since there was no barrier to prevent it, had also fallen into the roadside ditch. The manure and used bedding would be carried with the flow in the roadside ditch to the east and to the East Ditch where it eventually flowed into the perennial unnamed tributary.

IMGP0099: Main Barn has manure and used bedding piled in front of the barn (location indicated by red circle). Manure and used bedding is also in the roadside ditch in front of the Main Barn.

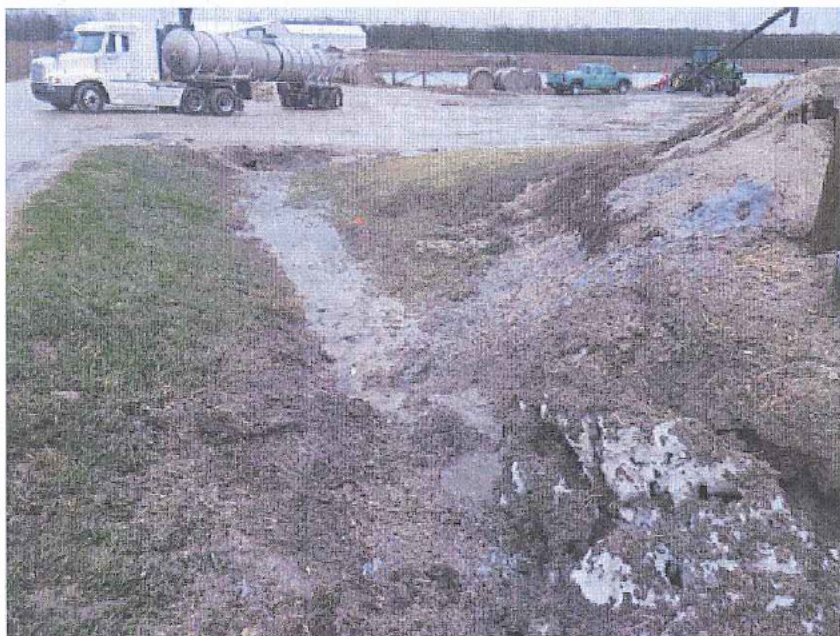
IMGP0102: Manure and used bedding, including the alternate bedding is piled in front of the northeast corner of the Main Barn. It is also in the roadside ditch.

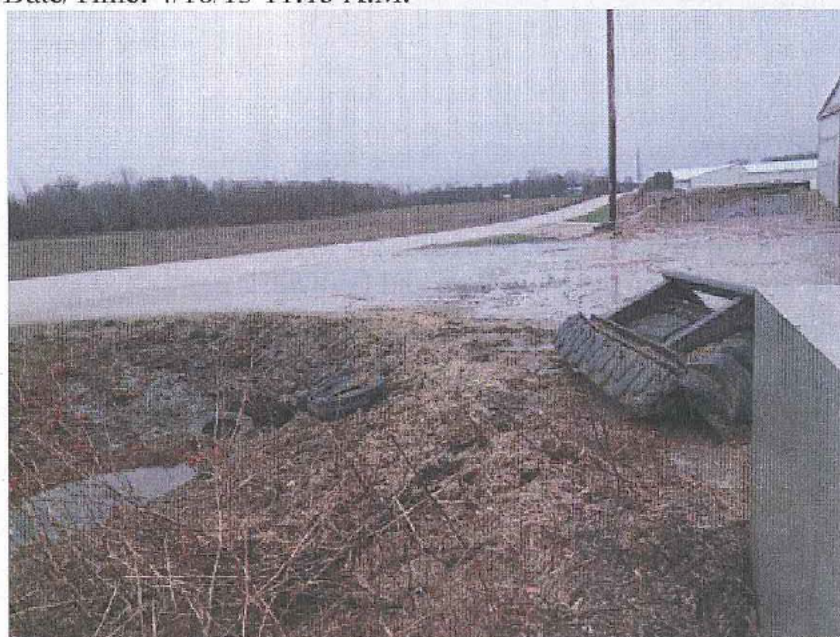
IMGP0106: Manure and used bedding in the roadside ditch north of the Main Barn from the northwest corner of the barn.

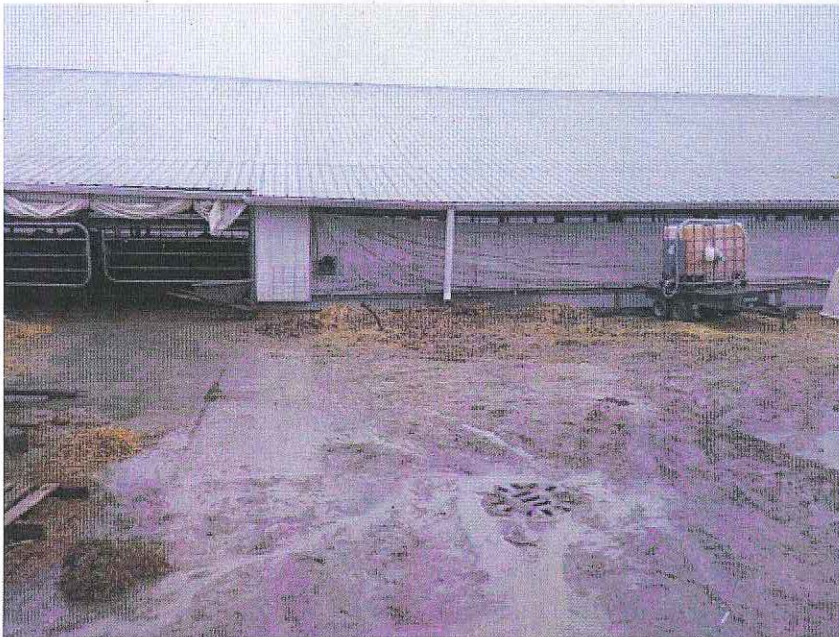
IMGP0110: Track in and track out of raw materials outside the Main Barn can flow to the inlet at the north end of the area between the Main Barn and Barn #2.

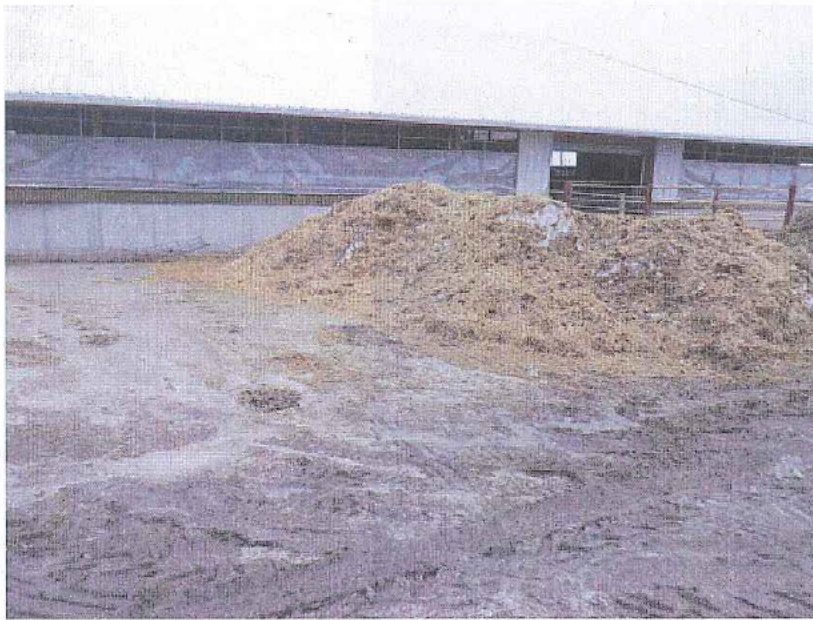
IMGP0116: Piles of used bedding scraped up with the snow are piled in the yard between the Main Barn and Barn #2. Process wastewater from the bedding can flow to this inlet on the south side of the area between the barns. The flow from the pipe outlets into Pasture #3 from a white pipe as shown previously in photo IMGP0069.

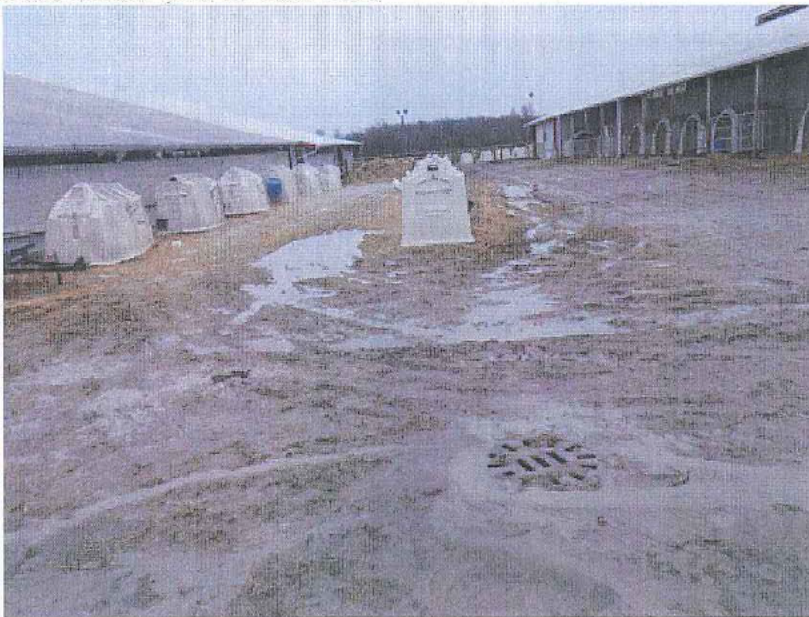
IMGP0109: Manure and process wastewater from the calf hutches can flow to the inlet and then to Pasture #3 via a pipe.

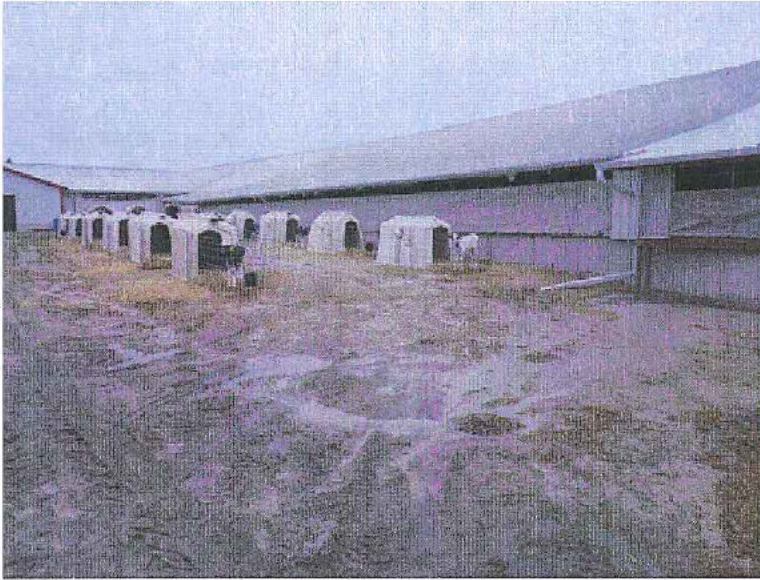
IMGP0117: Manure and process wastewater from the calf hutches also can flow to the south to the second storm water inlet.
